**Željko ARBANAS**

## **SMALL LANDSLIDES ON THE FLYSCH OF ISTRIA**

**SUMMARY:** This piece of work presents the "small" landslide occurrences in the part of the Istrian peninsula, named "Grey Istria", where the Paleogene flysch sediments shaped the terrain. This is the area of the very significant exogenetic processes, like erosion and accumulation of material. The fore mentioned landslides are of the relatively small dimensions and with landslide body volume lesser than  $20.000 \text{ m}^3$ . The sliding of material regularly occurs inside the weathering zone or in slope formations, while the slide surface is formed in the contact with the flysch bedrock. This paper deals with the landslide in the vicinity of the Krušvari settlement, which caused the damage of the local road in the section of Cerovlje-Buzet. It could be said that particular landslide is the typical one for the "Grey Istria" area, while its causes and sliding phenomena are similar to the numerous landslides in this region.

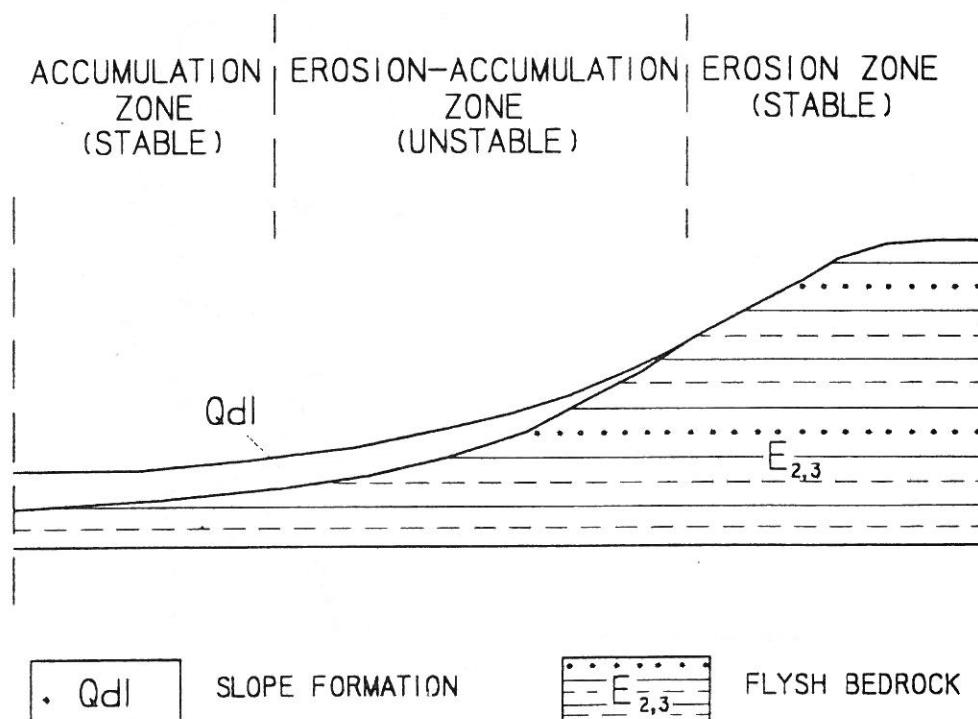
**Figure 2.** Generalised geological cross-section

In the process morphogenesis of this particular area of Istria, during the Pleistocene and Holocene period, the differential erosion of flysch areas occurred. Hilly sites were formed in parts of the terrain where more resistant sandstones and breccio-conglomerates were present. The greater load of mass was simultaneously deposited in the earlier eroded depressions. The eroded material still left on slopes is liable to sliding (fig. 2).

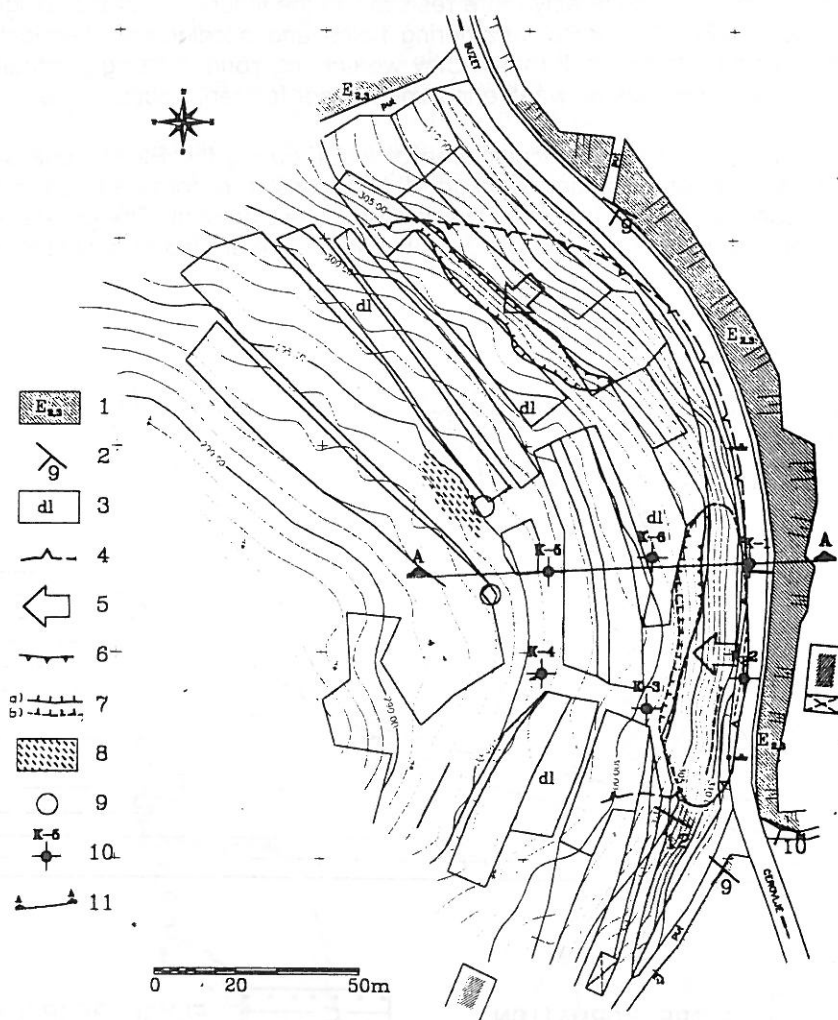
**Figure 3.** Engineering geological map of the landslide

The Krušvari landslide presents the typical example of the "small" landslide on flysch. Due to its dimensions it is one of the greater phenomena of that kind. The investigated area is situated on the local road between the Cerovlje settlement (near Pazin) and the town of Buzet near the northern entrance of the Krušvari settlement. The terrain is of the sloppy shape with terraces going downwards towards southwest. Cutting and filling during the road construction formed the higher part of the slope. The slope surface relief hypsometrically lower to the road, has been considerably changed during the terrace formation. The average slope inclination is  $14^{\circ}$ , while it ranges from  $10^{\circ}$  in the lower parts of the slope, to  $30^{\circ}$  below the roadbed. The surface with visible instability phenomena is not larger than 2 hectares (fig. 3)

On the basis of the engineering geological mapping and borehole drilling it was determined that the terrain was composed of the slope deposits-cover and flysch bedrock. In the upper flysch zone the weathering zone was established. Slope deposits cover the greater part of the investigated area. Flysch bedrock is visible at side cuts along the road (fig. 3).

Slope deposits are composed of the yellow-brown to grey-yellow high plastic clay. Depending on its moistening composition, clay is from firm to stiff consistency. There are 10% to 20% of sandstone fragment in clay. The lithogenetic unit thickness varies from 0.3 to 0.7 m in boreholes located on the road, while the thickness between 4.0 to 7.7 m's was measured in other boreholes along the slope. Road embankment, sand and stone mixture ranging from 0.9 to 1.4 m of thickness is situated in the narrow belt. Paleogene clastic sediments-flysch makes the bedrock base. It is lithologically heterogeneous complex. It is composed of siltstones, marls, and calcareous sandstones. Flysch rock mass is well bedded. The beds are slightly bent towards southwest. Flysch rock mass is strongly weathered, and therefore on the basis of the boring core inspection, it was possible to separate greater number of weathering zones, ranging from completely (WC) to highly (WH), moderately (WM) and slightly weathered (WS) to the fresh or intact rock mass (FR) (ISRM, 1978). Weathering zone thickness differentiates in each borehole regarding to its different lithological composition. During the period of great rains in spring 1993 the part of material sliding on road embankment occurred, and consequently caused the road damage in length of 30 m. On this part of the section a part of the roadbed was carried away, causing damage on the southern traffic line of the road.

But the overall potentially unstable zone is much bigger. The zone head is clearly limited with the stable flysch rock mass phenomenon, visible on surface in the hypsometrically higher part of the slope, along the road-cut. On the opposite side, the lateral boundaries and the landslide toe can not be separated without larger and longer measurements, and therefore they are given in approximate values (fig.3).

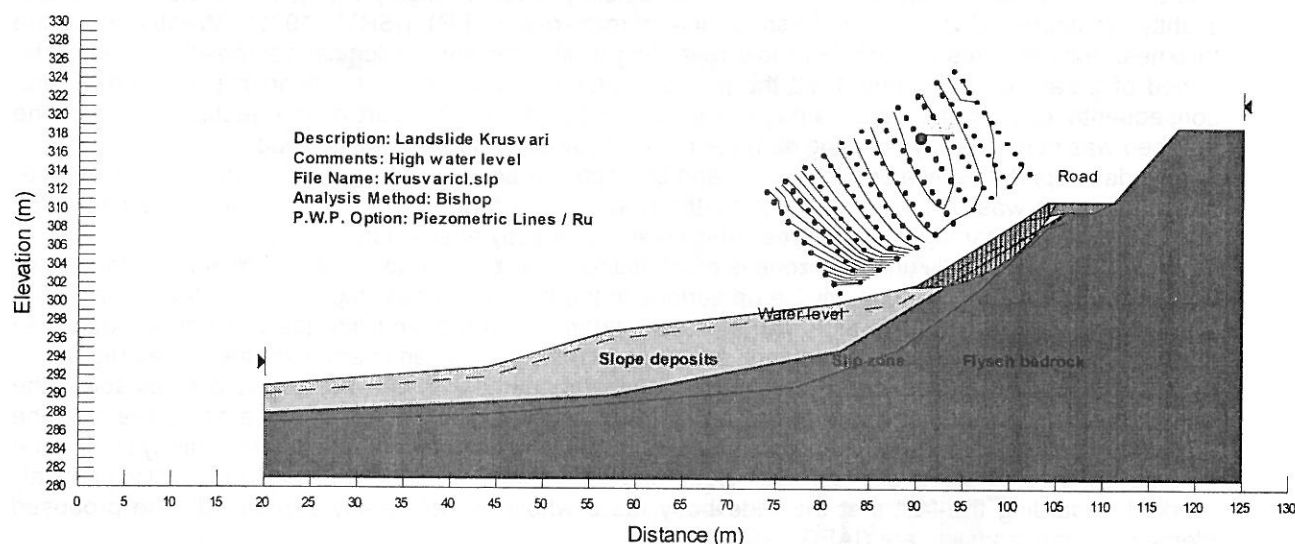
Fig. 4. Results of slope stability analysis

Slope stability analyses were carried out after the field and laboratory investigations, with the help of PC and the SLOPE/W V4, GEO-SLOPE (Geo Slope, 1998) program package, used for the present slope condition in the critical profile. The investigation stated with the hypothesis of the extreme hydrogeological conditions-the groundwater level in the upper part of the slope is nearly on surface, while in the lower part it comes out on surface. The calculation stimulates the higher groundwater level (10 m below the field surface in the lower part of the slope). Such conditions cause the lower level of safety factor below 1.0, or very probable sliding phenomenon in the upper part of the slope. For the purpose of the existing geometry on that particular location, three analyses have been carried out (for the upper, middle and the slope toe). The critical slip surface with the lowest safety factor (0.9) was estimated in the upper part of the slope. The critical slip surface corresponds the depicted traces of sliding, or road damages, in regard to their location (fig. 4).

1. The change of geometrical slope relief in its upper part with more effective water drainage;
2. The constant lowering of groundwater levels with subsoil drainage system construction.

As more rational solution the groundwater level lowering was chosen, without major interventions in slope geometry. The permanent level lowering, except from different orientation of hydrodynamic forces and their decrease, enables the cover water content lowering. That leads to cohesion increase as well as the shear strength of material in the slip surface zone. Slope stability controls with the groundwater lowering suggest the larger increase of safety factor in the area of the entire slope.

The construction of the boring drain pipes on the embankment's toe, as well as the overall drainage system serve as the intervention at that particular location.
